# New Hampshire Volunteer Lake Assessment Program

## 2003 Interim Report for Lake Massasecum Bradford

NHDES  
Water Division  
Watershed Management Bureau  
29 Hazen Drive  
Concord, NH 03301

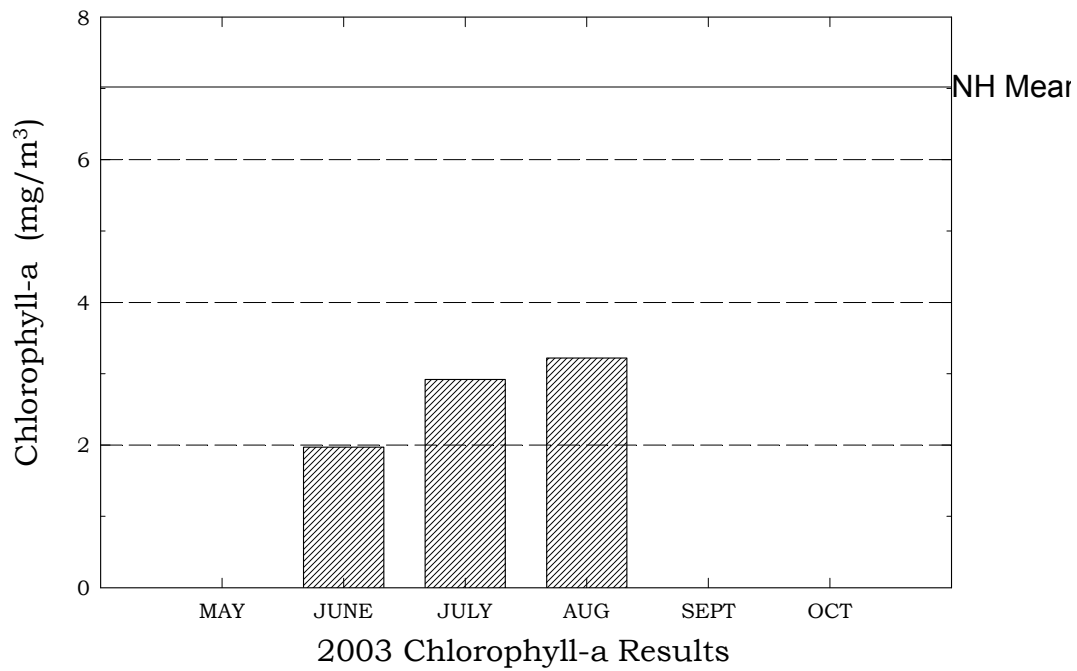
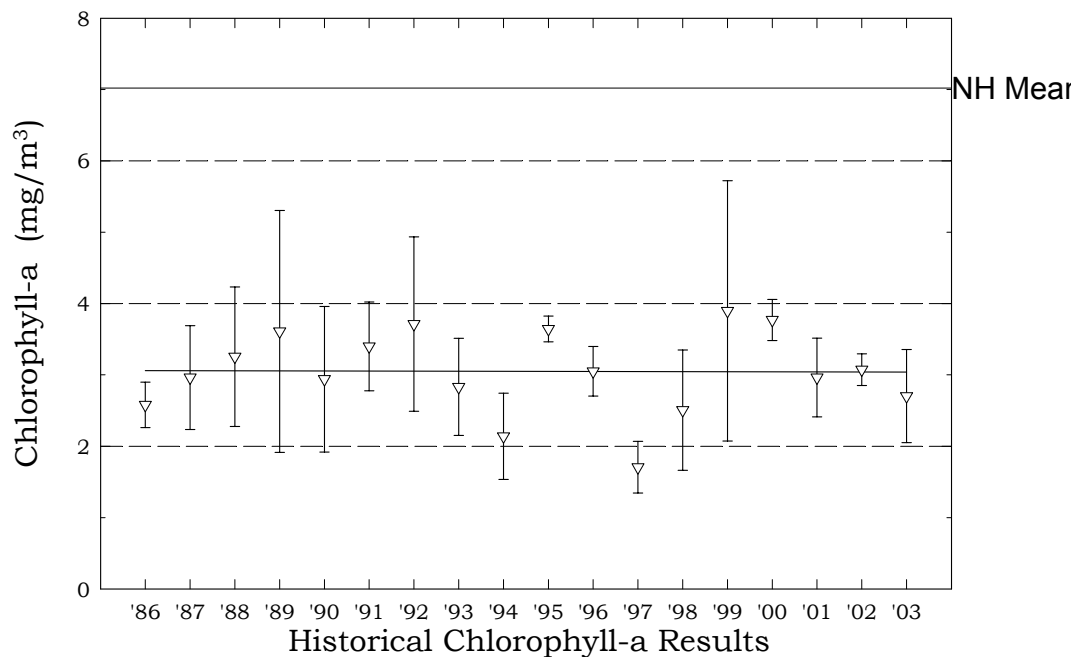
**Figure 1.** Monthly and Historical Chlorophyll-a Results

- **Figure 1 and Table 1:** The graphs in Figure 1 (Appendix A) show the historical and current year chlorophyll-a concentration in the water column. Table 1 (Appendix B) lists the maximum, minimum, and mean concentration for each sampling season that the lake/pond has been monitored through the program.

The current year data (the top graph) show that the chlorophyll-a concentration **increased consistently** from June to August. The chlorophyll-a concentration on each sampling event was ***much less than*** the state mean.

Overall, visual inspection of the historical data trend line (the bottom graph) shows ***a relatively stable*** in-lake chlorophyll-a trend. Specifically, since monitoring began in 1986, the mean annual chlorophyll has ranged between 2 and 4 mg/m<sup>3</sup>, which is ***less than***

While algae are naturally present in all lakes/ponds, an excessive or increasing amount of any type is not welcomed. In freshwater lakes/ponds, phosphorus is the nutrient that algae depend upon for growth. Algal concentrations may increase with an increase in nonpoint sources of phosphorus loading from the watershed, or in-lake sources of phosphorus loading (such as phosphorus releases from the sediments). Therefore, it is extremely important for volunteer monitors to continually educate residents about how activities within the watershed can affect phosphorus loading and lake/pond quality.

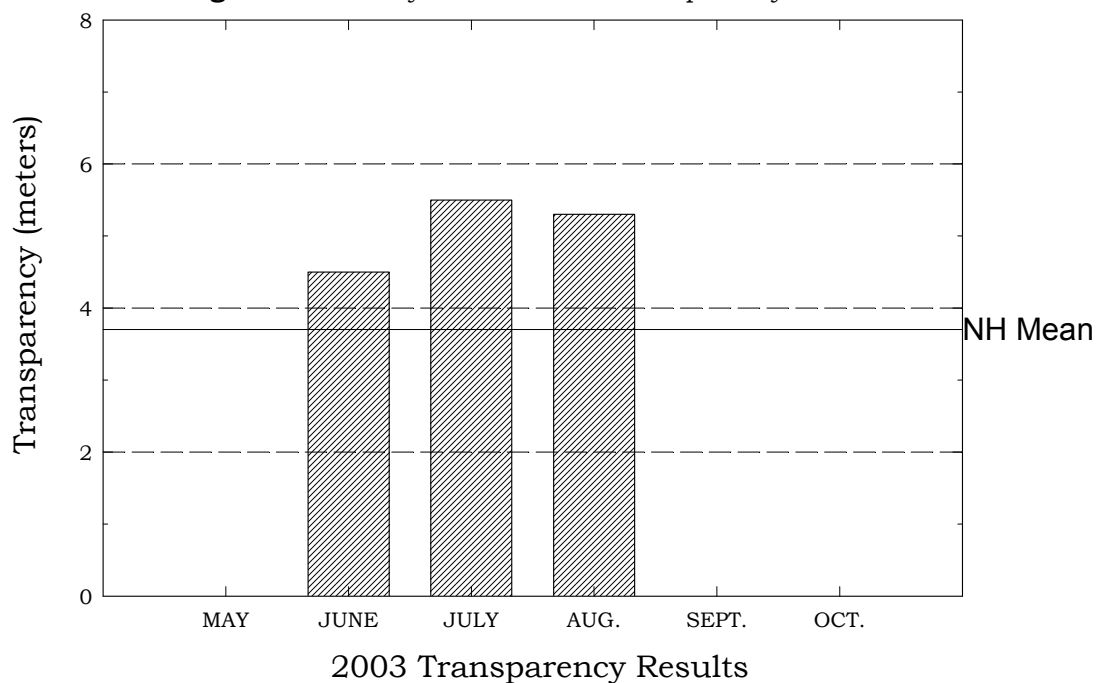
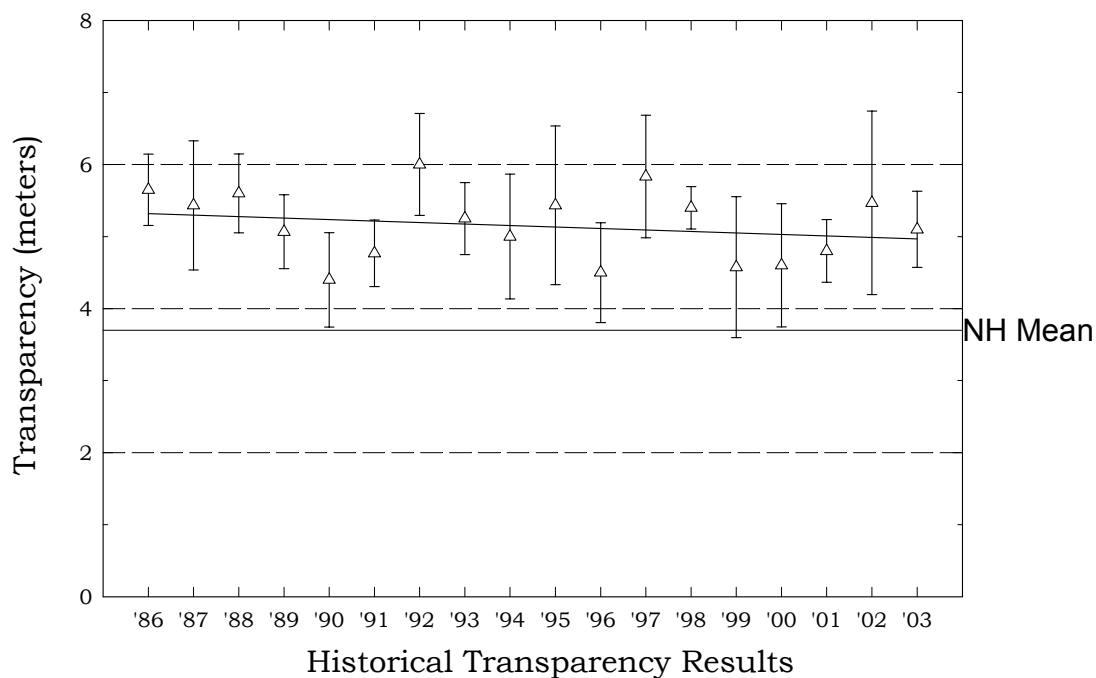
**Figure 2.** Monthly and Historical Transparency Results

- **Figure 2 and Table 3:** The graphs in Figure 2 (Appendix A) show historical and current year data for lake/pond transparency. Table 3 (Appendix B) lists the maximum, minimum and mean transparency data for each sampling season that the lake/pond has been monitored through the program.

The current year data (the top graph) show that the in-lake transparency **increased** from June to July, and then **decreased slightly** from July to August. The transparency on each sampling event was **greater than** the state mean.

Overall, visual inspection of the historical data trend line (the bottom graph) shows **a relatively stable** trend for in-lake transparency. Specifically, the mean annual transparency has ranged between approximately 4.5 and 6.0 meters since monitoring began in 1986. Again, in the 2004 annual report, we will conduct a statistical analysis of the historic data to objectively determine if there has been a significant change in the annual mean transparency since monitoring began.

Typically, high intensity rainfall causes erosion of sediments into lakes/ponds and streams, thus decreasing clarity. Efforts should continually be made to stabilize stream banks, lake/pond shorelines,

disturbed soils within the watershed, and especially dirt roads located immediately adjacent to the edge of tributaries and the lake/pond. Guides to Best Management Practices designed to reduce, and possibly even eliminate, nonpoint source pollutants, such as sediment loading, are available from DES upon request.

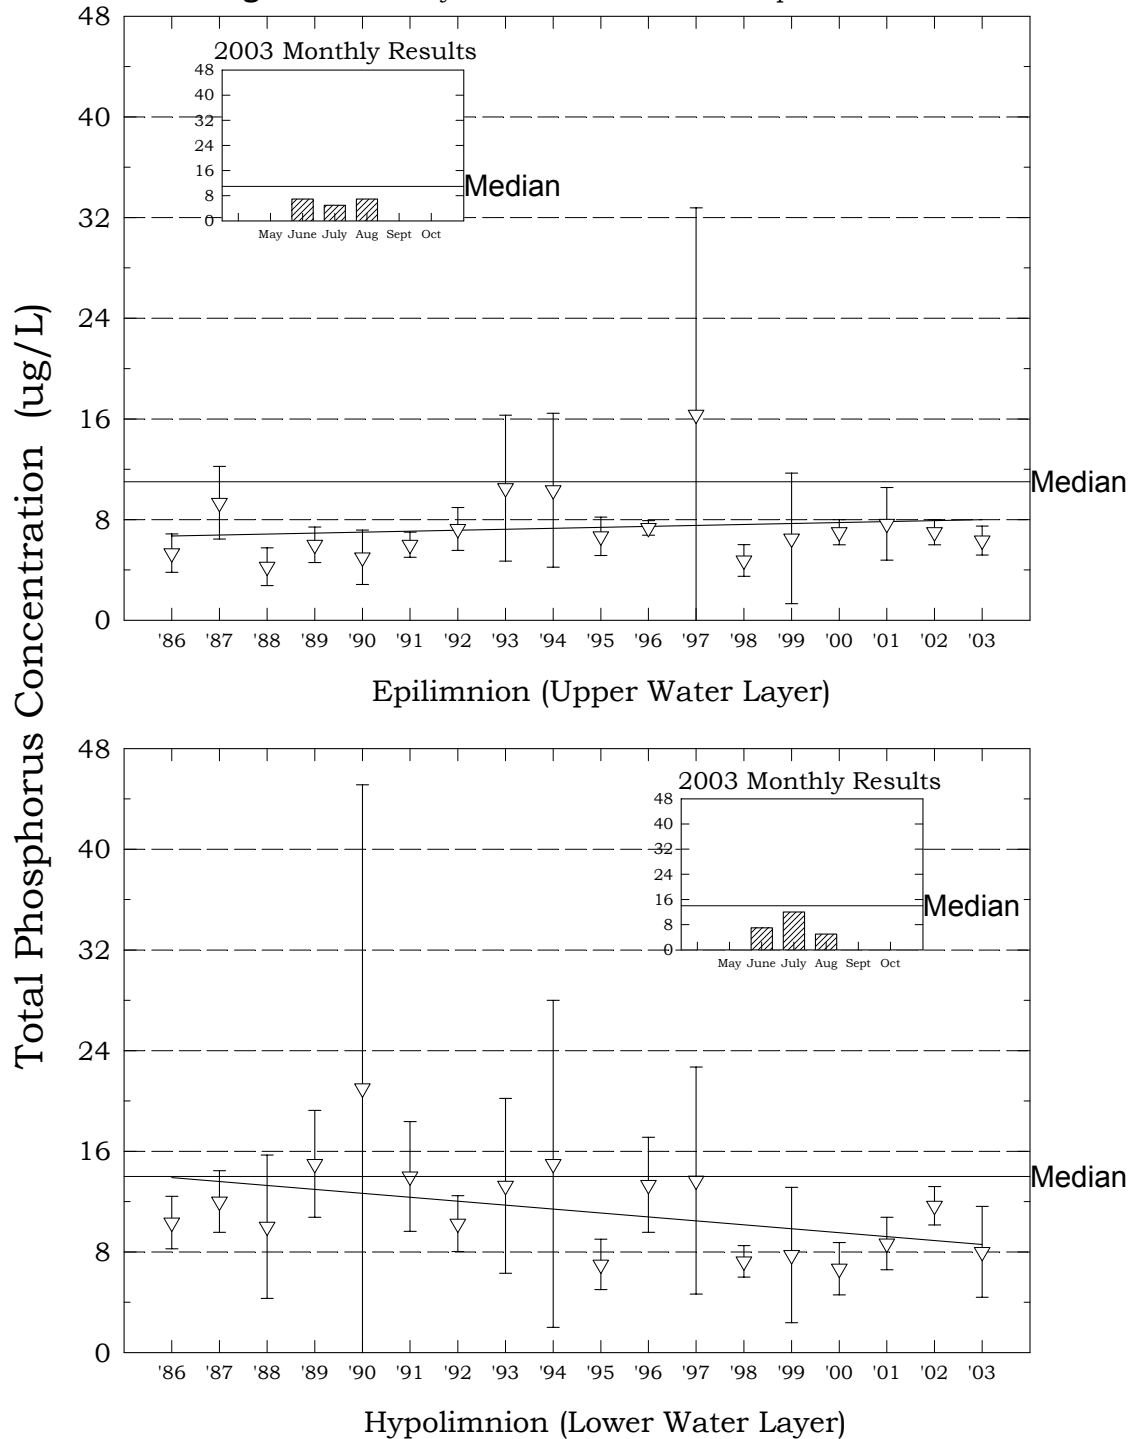
**Figure 3.** Monthly and Historical Total Phosphorus Data.

- **Figure 3 and Table 8:** The graphs in Figure 3 (Appendix A) show the amounts of phosphorus in the epilimnion (the upper layer) and the hypolimnion (the lower layer); the inset graphs show current year data. Table 8 (Appendix B) lists the annual maximum, minimum, and median concentration for each deep spot layer and each tributary since the lake/pond has joined the program.

The current year data for the epilimnion (the top inset graph) show that the phosphorus concentration **decreased slightly** from June to July, and then **increased slightly** from July to August. The phosphorus concentration on each sampling event was **less than** the state median.

The current year data for the hypolimnion (the bottom inset graph) show that the phosphorus concentration **increased** from June to July, and then **decreased** from July to August. The phosphorus concentration on each sampling event was **less than** the state median.

Overall, visual inspection of the historical data trend line for the epilimnion shows **a relatively stable** phosphorus trend since monitoring began. Specifically, the mean annual epilimnetic phosphorus concentration has ranged between approximately 6 and 10 ug/L, which is **less than** the state median (aside from the data collected in 1997).

Overall, visual inspection of the historical data trend line for the hypolimnion shows **a variable** phosphorus trend. This means that the phosphorus concentration has **fluctuated** in the hypolimnion since monitoring began. The majority of the annual mean hypolimnetic phosphorus concentrations have been **less than** the state median since monitoring began.

One of the most important approaches to reducing phosphorus loading to a waterbody is to continually educate watershed residents about its sources and how excessive amounts can adversely impact the ecology and value of lakes and ponds. Phosphorus sources within a lake or pond's watershed typically include septic systems, animal waste, lawn fertilizer, road and construction erosion, and natural wetlands.
